DOT/FAA/W/92-1  
DOT-VNTSC-FAA-92-6

## 1991 LLWAS Anemometer Test Program

Final Report  
September 1992

U.S. Department  
of Transportation  
Federal Aviation  
Administration

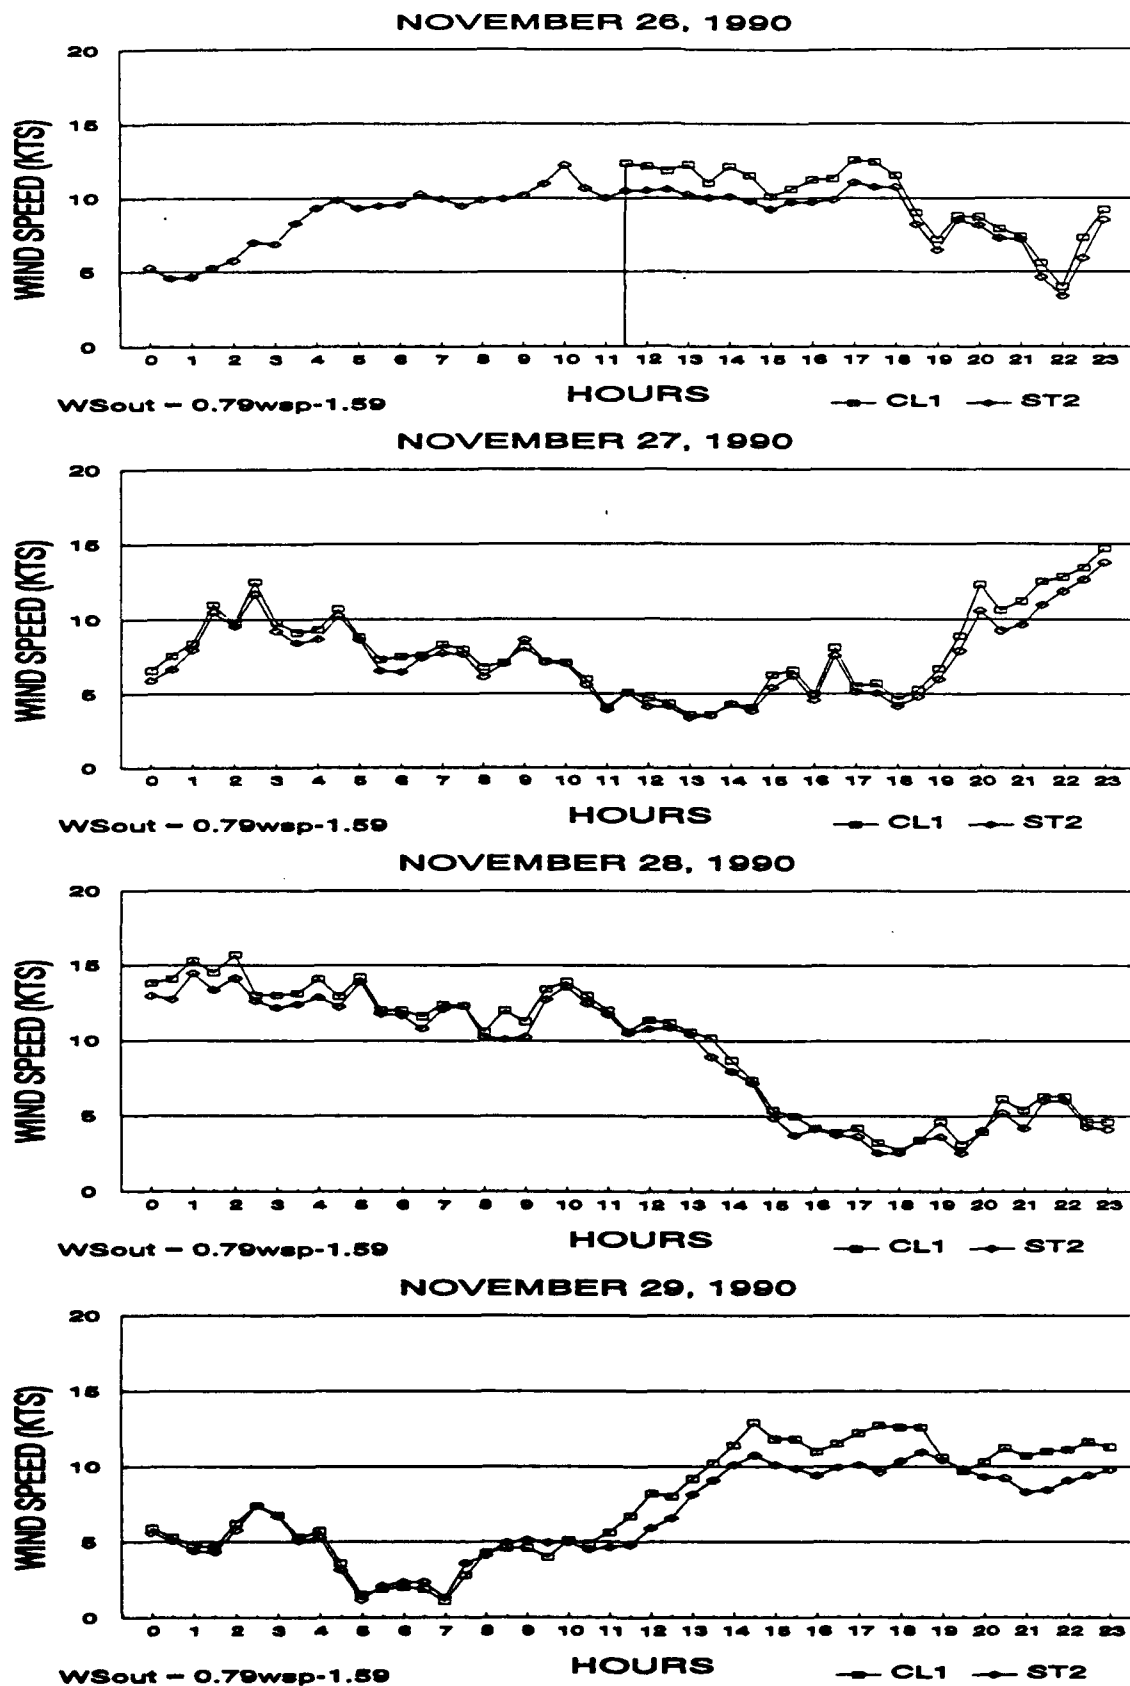
**FIGURE 4-9. COMPARISON OF ST2 AND CL1 WIND SPEED ON 11/26-29/90**

Figures 4-8 through 4-11 show wind speed plots for all the sensors operating during this event, which occurred very early in the test period. Figure 4-8 shows that the two Climatronics sensors tracked well through the event; CL2 was not in service after the event. Figure 4-9 shows agreement to within 1.5 knots between ST2 and CL1 through the event and for the following day. Larger disagreements were noted on the day before and the second day after the event when the wind direction was southerly. Figures 4-10 and 4-11 show variable agreement between the two Rosemount sensors and CL1; the errors are larger at low wind speeds, as would be expected for the pressure-sensing Rosemount units.

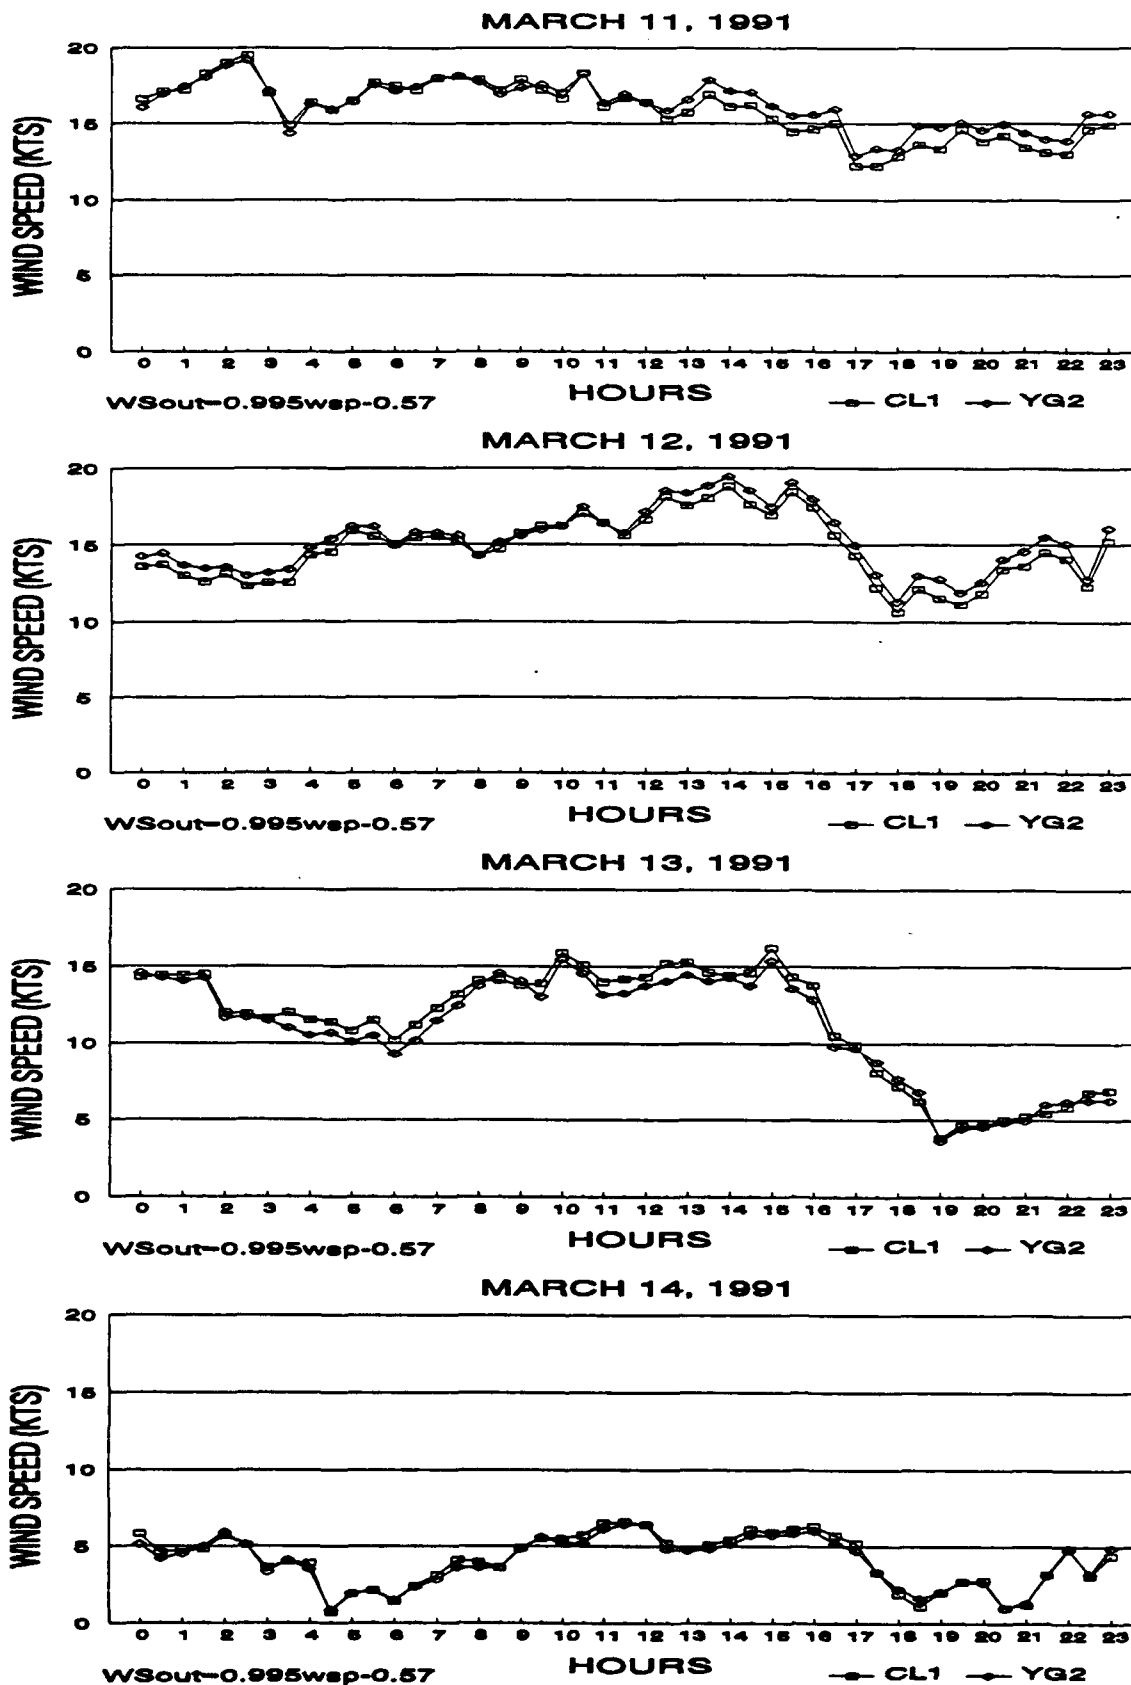
FIGURE 4-14. COMPARISON OF YG2 AND CL1 WIND SPEED ON 3/11-14/91

Figures 4-13 and 4-14 show wind speed plots for the two R. M. Young sensors (YG1 and YG2). In Figure 4-14, YG2 agrees well with CL1 throughout the event. In Figure 4-13, however, YG1 slowed down by 1.5-2 knots during 0400-0500 hours and during 0600-1030 hours. The maximum speed reduction was reached by 0430 and 0700 hours. The second speed reduction period corresponded to the observer's report (see Table 4-2.) of light freezing rain, icing indications from the Rosemount icing sensor, and a temperature near freezing (33 degrees). Neither the observer nor the Rosemount icing sensor indicated any icing during the first speed reduction period.

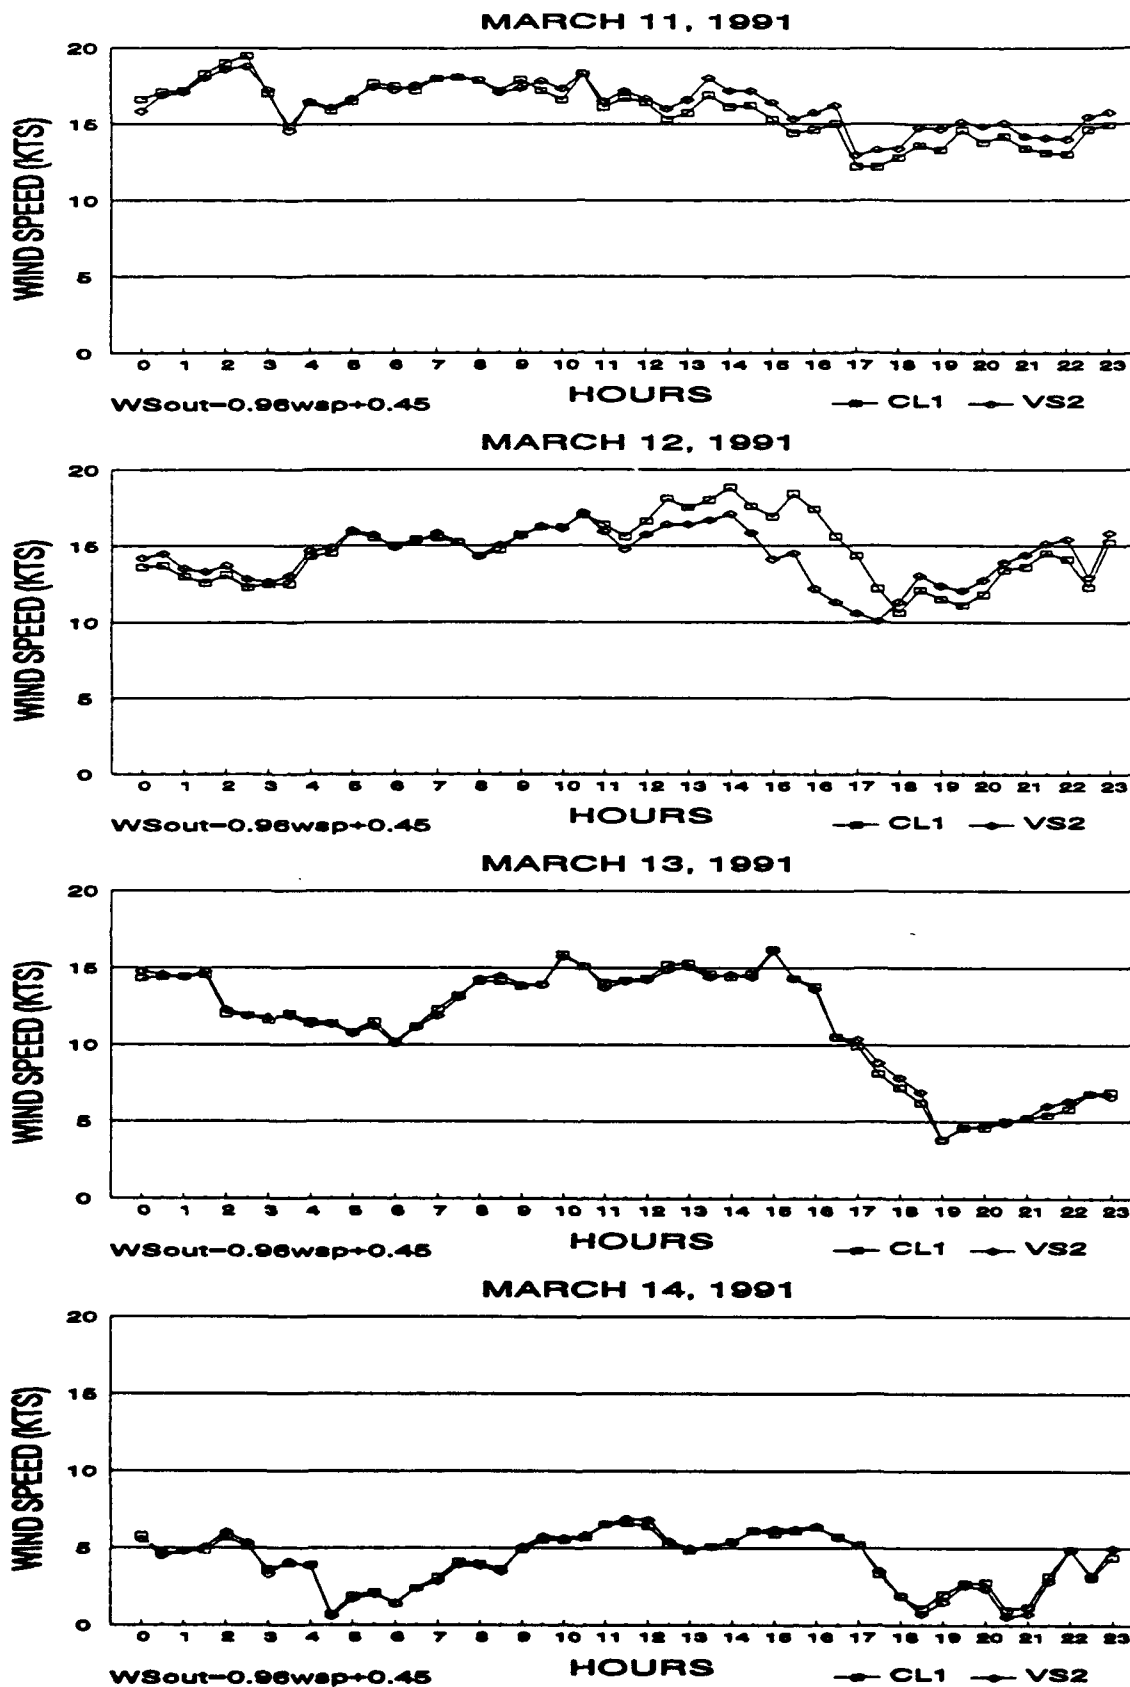
FIGURE 4-16. COMPARISON OF VS2 AND CL1 WIND SPEED ON 3/11-14/91

Figures 4-15 and 4-16 show wind speed plots for the two Vaisala sensors (VS1 and VS2). VS1 and VS2 began to indicate lower wind speeds than CL1 at 1230 and 1100 hours, respectively. They both reached a maximum reduction at 1530-1600 hours and recovered by 1800 hours. The maximum speed loss for VS1 and VS2 was 4 and 5 knots, respectively, out of a wind speed of 17 knots; the speed loss was thus 24 and 29 percent, respectively. According to Table 4-2, this loss of speed occurred during the first segment of light snow when the temperature was not very far below freezing (minimum of 27 degrees). The

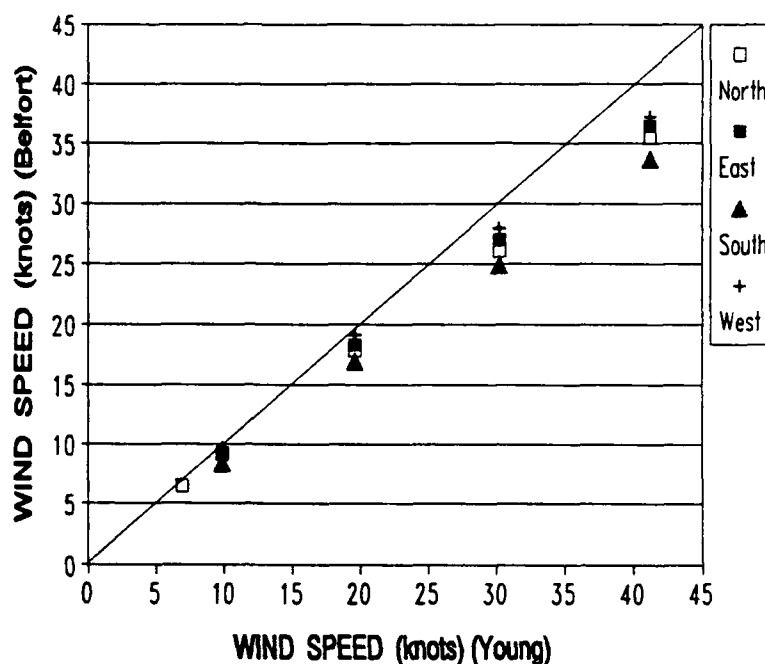
FIGURE 5-5. BELFORT HOT-WIRE CALIBRATION (S/N 10066)

Figure 5-5 shows the calibration of one Belfort hot-wire unit. Although the unit was seriously out of calibration, the response appeared to be linear.

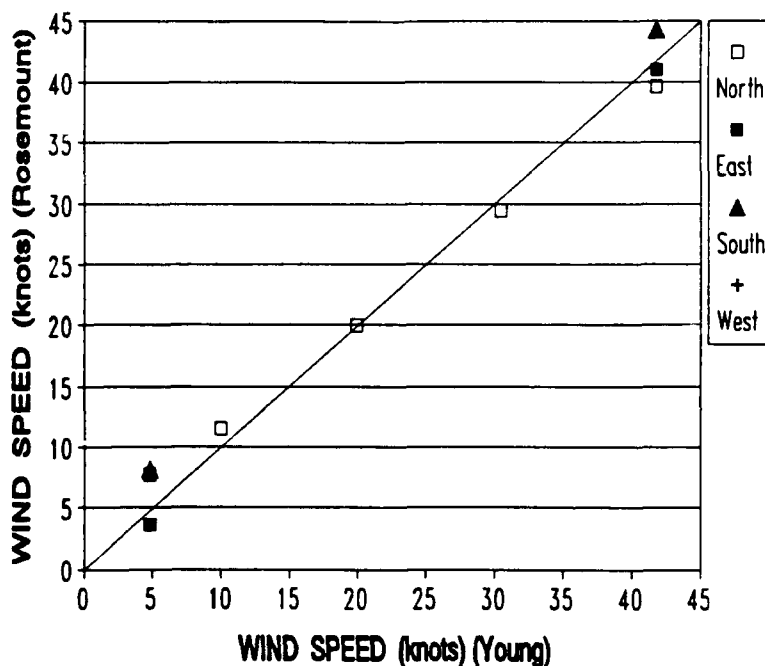
FIGURE 5-7. ROSEMOUNT CALIBRATION (S/N LLWAS2)

Figures 5-6 and 5-7 show the calibrations of the two Rosemount sensors. Four wind directions (north, east, south, and west) were tested for most wind speeds. RS1 (S/N LLWAS1) had been modified during the field testing to improve its response at low wind speeds. This modification limited RS1 to measuring wind speeds to a maximum of about 35 knots. RS2 (LLWAS2) was tested at wind speeds over the normal range (up to 42 knots).

Both Rosemount sensors showed somewhat greater differences from the R. M. Young reference sensor at low wind speeds than at high wind speeds, as would be expected for a pressure sensor. Since the signal is proportional to the square of the wind speed, a pressure offset will produce a greater error at lower wind speed. The modified RS1 sensor did show at best, a slight improvement in performance over the other Rosemount unit at the low wind speeds, but the improvement was at the cost of
